**Region 9 Enforcement Division
75 Hawthorne Street
San Francisco, CA 94105**

Inspection Date(s):	August 21, 2019		
Time:	Entry: 9:00 am	Exit: 10:30 am	
Media:	Water		
Regulatory Program(s)	Clean Water Act NPDES		
Company Name:	Dos Cuadras Offshore Resources, LLC (DCOR)		
Facility or Site Name:	Platform Habitat		
Facility/Site Physical Location:	Platform Habitat, Santa Barbara Channel, Pacific Ocean Lease OCS-P-0234		
Geographic Coordinates:	34°17'12.31"N, 119°35'19.23"W		
Mailing address:	290 Maple Court, Suite 290 Ventura, CA 93003		
Facility/Site Contact:	Jay Rao	Title: Environmental Engineer	
	Phone: 805-535-2078	Email: jrao@dcorllc.com	
Facility/Site Identifier:	NPDES Permits CAG280000 and CAF001304		
NAICS:	211111 - Crude petroleum and natural gas extraction		
SIC:	1311		
Facility/Site Personnel Participating in Inspection:			
	Name	Affiliation	Title
			Email
	Jay Rao	DCOR	Environmental Engineer jrao@dcorllc.com
	Jacob Ruth	DCOR	Lead Operator habitatuser@dcorllc.com
EPA Inspector(s):

On August 21, 2019, Adam Howell and Michael Weiss from the U.S. EPA Region 9 Enforcement Division (hereafter, we or inspection team) conducted a Clean Water Act (CWA) National Pollutant Dischar

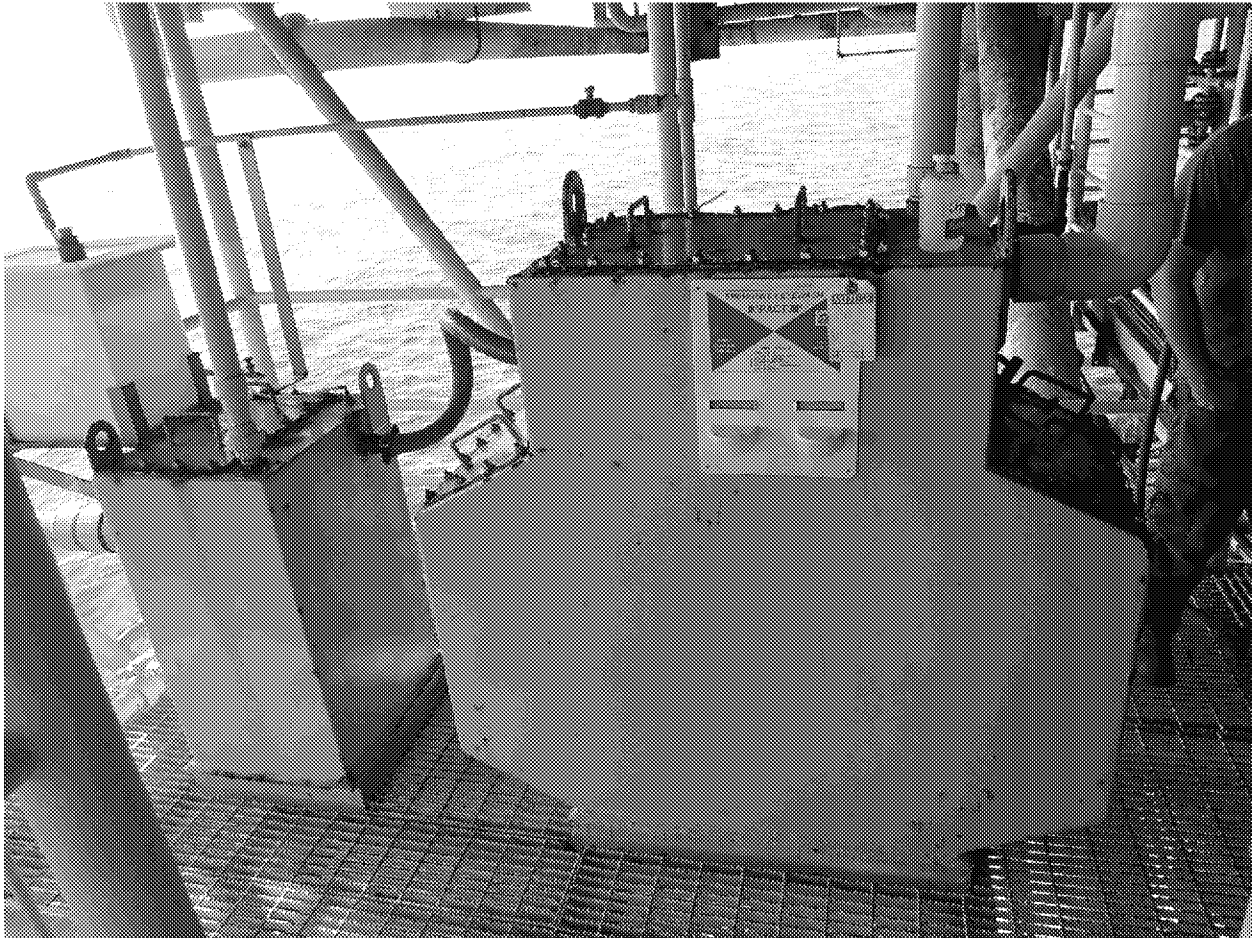
Sanitary Wastewater (Discharge 005) is treated onsite at the Facility with a redFox environmental marine sanitation device (MSD) which is United States Coast Guard (USCG) approved (Photograph 1). The treated water is discharged (Discharge 005) to the Pacific Ocean via a pipe (Photograph 2). The onsite Facility representatives stated that the daily discharge water flow rate is estimated based on the number of people on the platform and the time spent per person. The MSD unit is sized for a maximum of 500 gallons per day (gpd).

Sanitary wastewater (Discharge 005) is ~~not~~ treated onsite at the Facility. Discharge 005 is treated via a redFox MSD (Photograph 1). The self-contained treatment system is composed of an aeration chamber, flocculation, solids settling, media filtration, and disinfection. The Platform chlorinates the treated effluent and checks the chlorine residual daily. The MSD is serviced annually by a contractor. The MSD was shutdown from January 2019 – June 2019 when the platform was unoccupied.

Photograph 1: RedFox Marine Sanitation Device

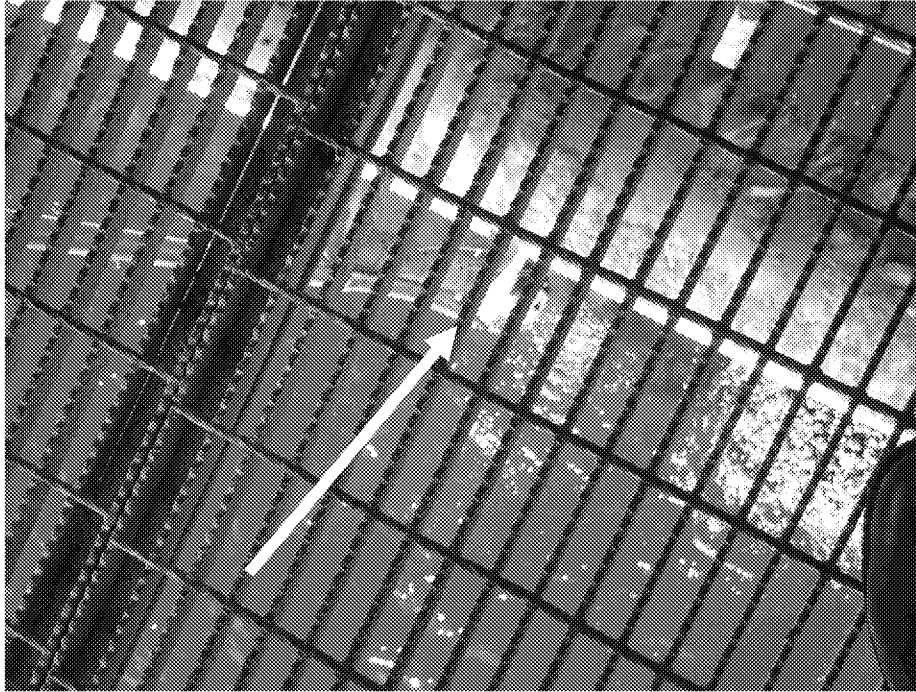
Photograph 2: Marine Sanitation Device discharge location.

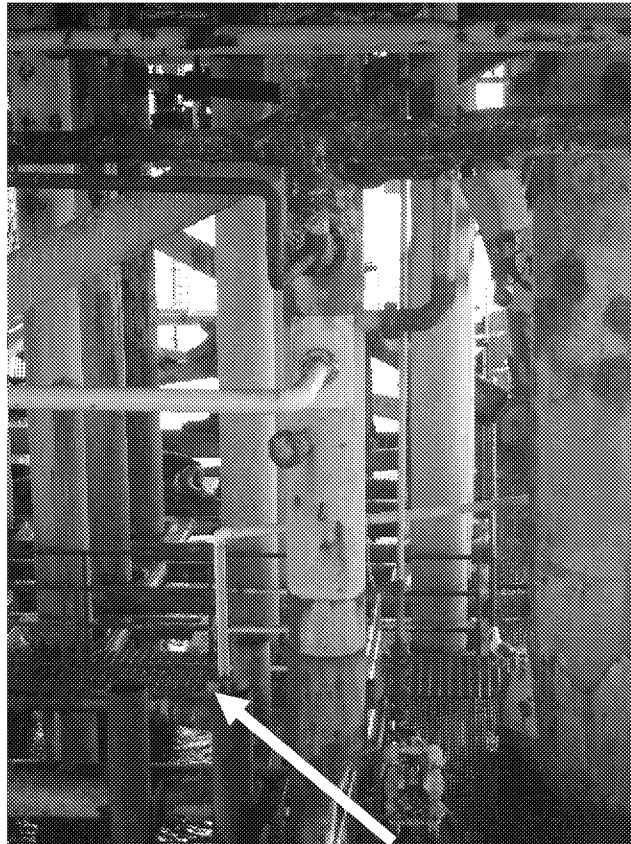
Desalination (i.e., reverse osmosis) unit wastewater (Discharge 007) is generated during the process of creating freshwater from saltwater. According to onsite Facility representatives, the desalination unit was not working at the time of the inspection. A new unit was to be installed soon and will only provide water to sinks and showers at the Facility. RO reject water will be discharged to the Pacific Ocean via a pipe (Photograph 3).

Photograph 3: RO Reject water discharge pipe

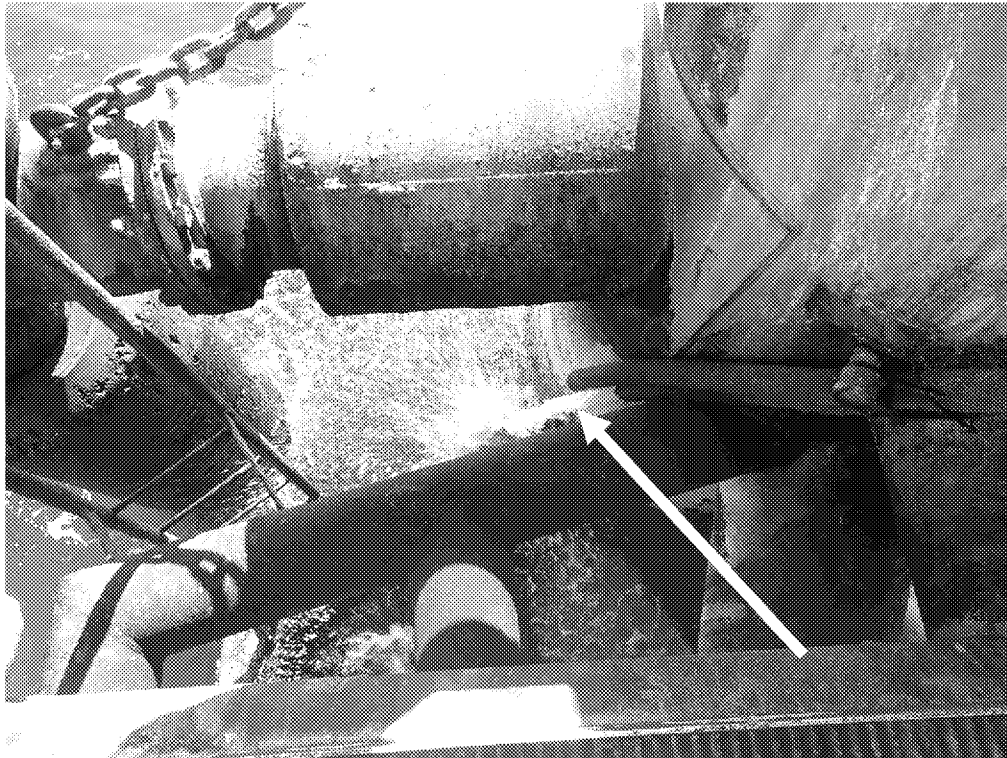
Fire control system water (seawater released during training, testing, and maintenance of fire protection equipment – Discharge 008) is composed of pure seawater that is constantly circulating throughout the Platform. The Fire control water is discharged through the pipes in (Photograph 4) without treatment.

Photograph 4: Fire water discharge.

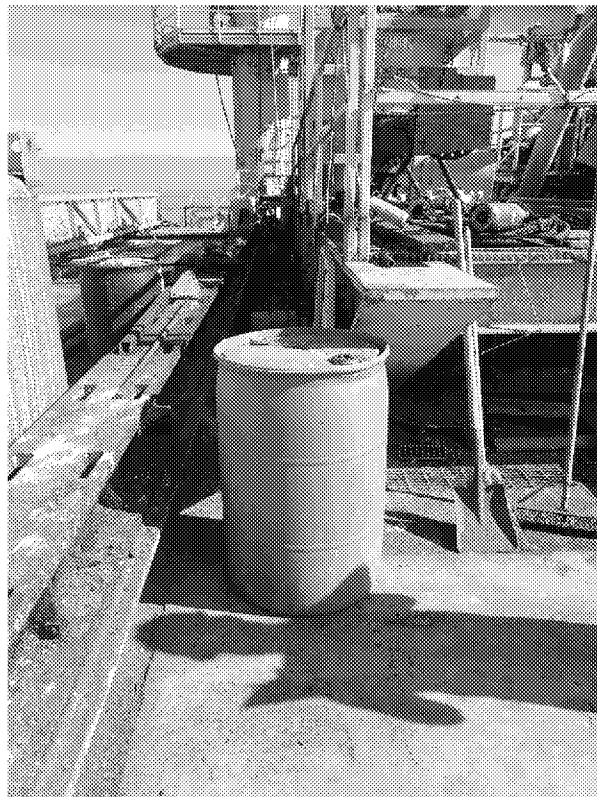
- During the Facility walk through, we observed one unlabeled 55-gallon drum (Photograph 5) on the Drill Deck and two unlabeled 55-gallon drums (Photographs 6 & 7) on the production deck. Mr. Ruth stated that samples from two of these drums were at the lab awaiting analyses to determine proper disposal methods. He told us the remaining drum was to be sampled for analysis in the near future.
- The NPDES permit, daily reports, and DMRs were all well organized and readily available on an electronic share drive accessible on the Platform.
- The platform had significant rust and corrosion and in places the floors seemed unsound.

Photograph 5 : Unlabeled drum on drill deck.

1. While a certain amount of rust and corrosion is to be expected in a harsh marine environment, the Facility should ensure that the corrosion does not negatively impact that operations or safety of the Platform or its ability to comply with the Clean Water Act.
2. The Facility needs to follow through on proper disposal of unlabeled chemicals.

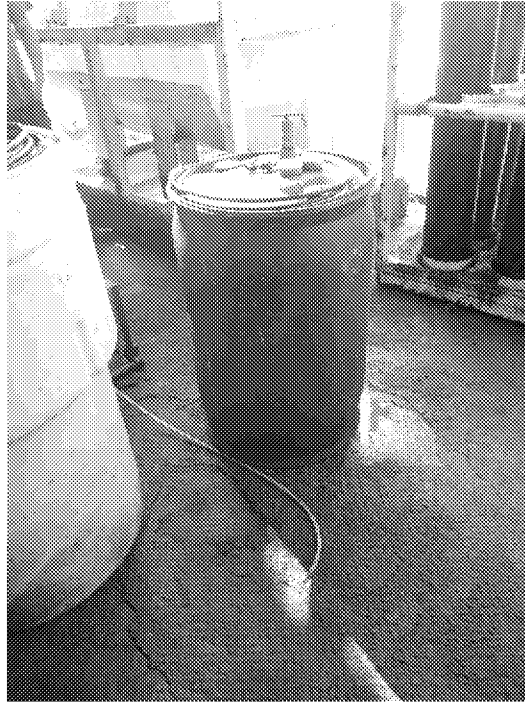
Photograph 6 : Unlabeled drum on production deck.

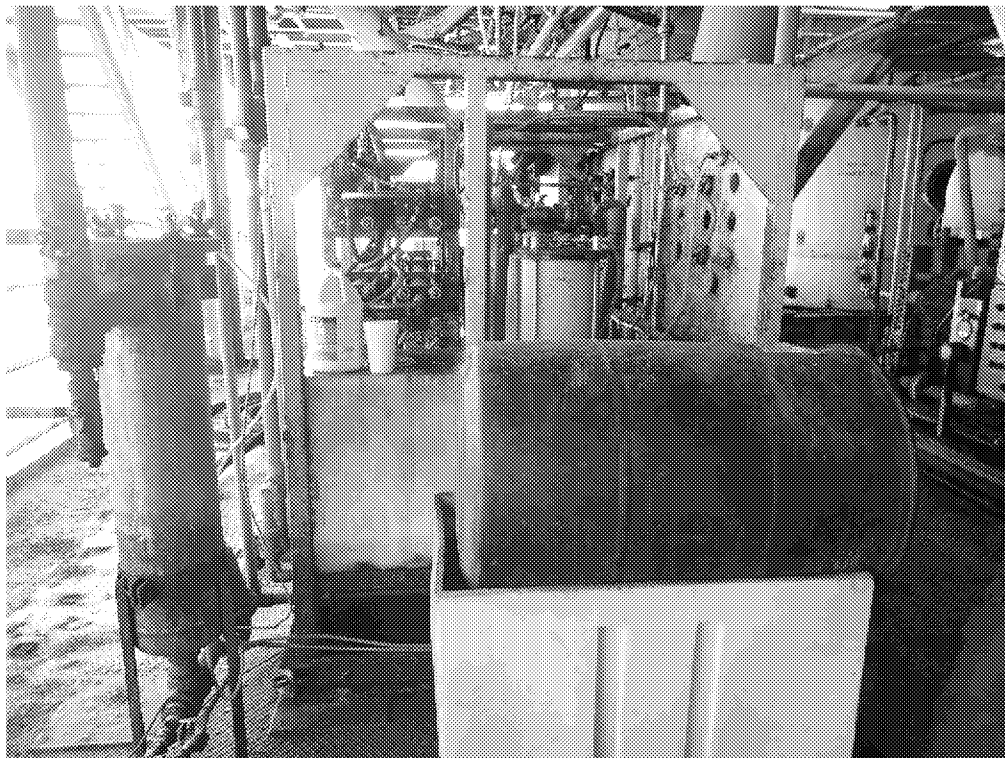
Photograph 7: Unlabeled drum on production deck.
